# Failure analysis 101

**When the irrigation system blows, a little detective work helps determine the cause.**

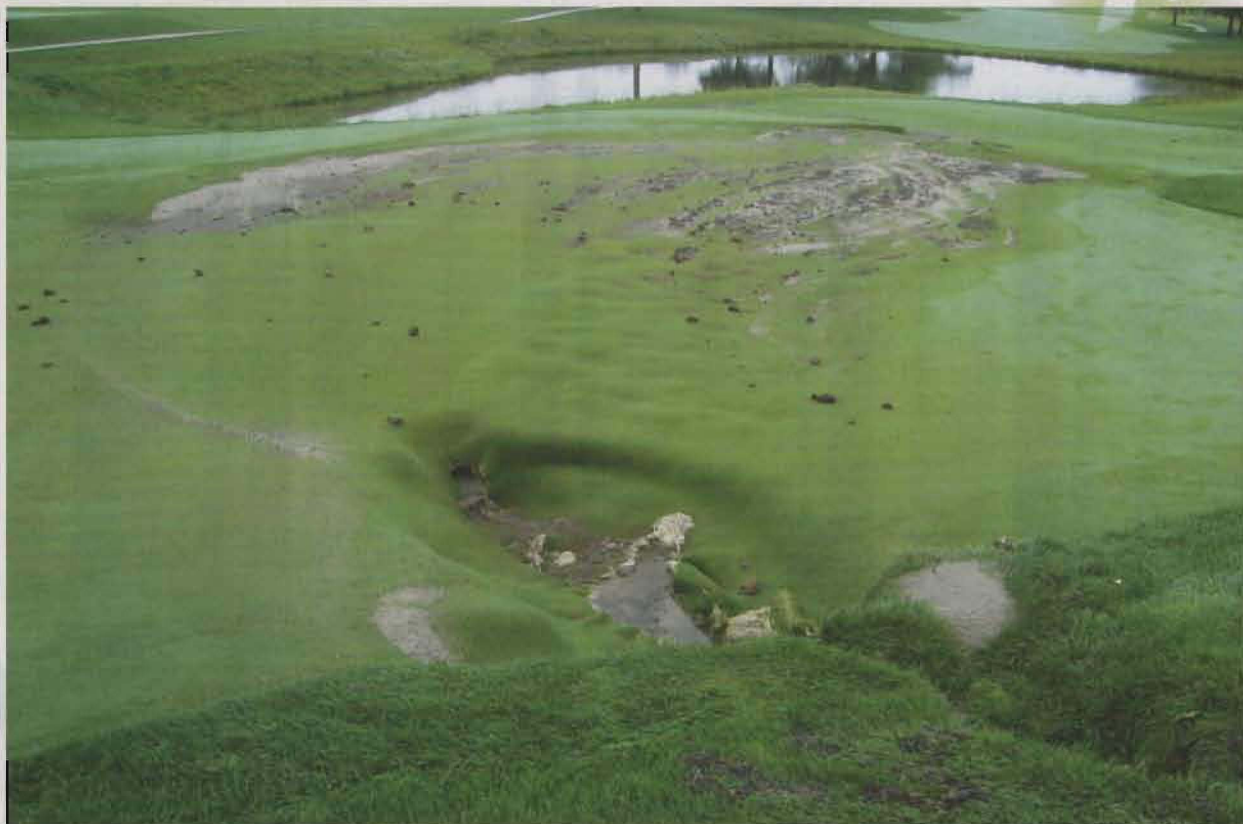
Early in the first summer following the complete reconstruction of the Lawrence (Kan.) CC course, then-superintendent Brad Minnick came to work and was confronted by this scene on No. 6. The diagnosis: Heavy rain combined with settling caused a thrust block at the irrigation run's end to give way. *Photo courtesy of Lawrence CC*

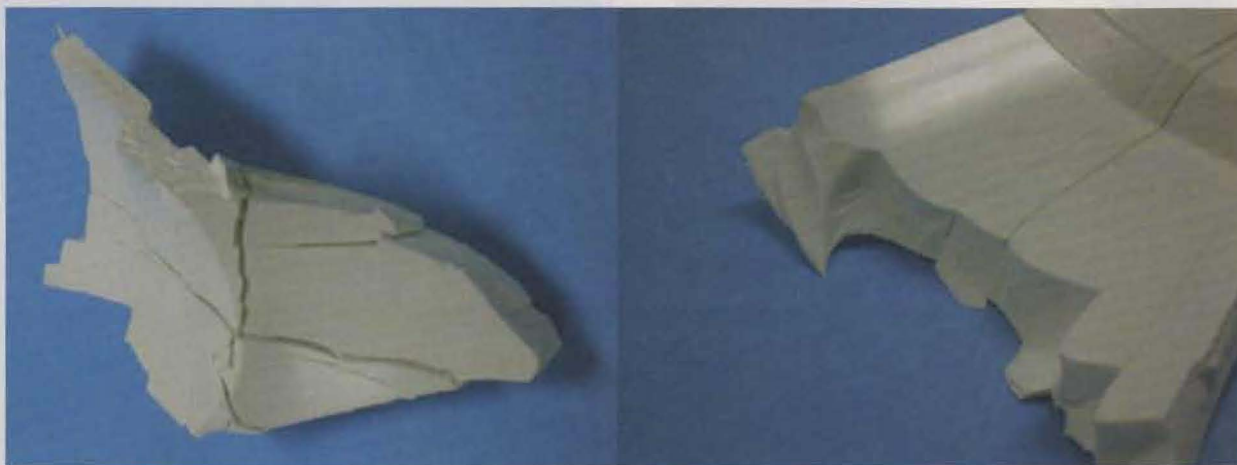
The sharp, jagged edges of this PVC piping indicate a failure from extreme pressure and probably were found after a burst-pressure test. Photos courtesy of Larry Workman

The texture of the failure surface shows a lot about its progression. Sharp, jagged edges are a strong sign of rapid failure. Brittle material or failures from extreme pressure result in almost razor-sharp fragments.

You'll usually find damage of this type after a burst-pressure test. When a water-filled system is pressure-tested, the sharp and dangerous fragments will be contained within a few yards. But when the system has been leak-tested with air or has an air pocket, a failure can propel these shrapnel-like pieces hundreds of feet, creating the potential for serious injury.

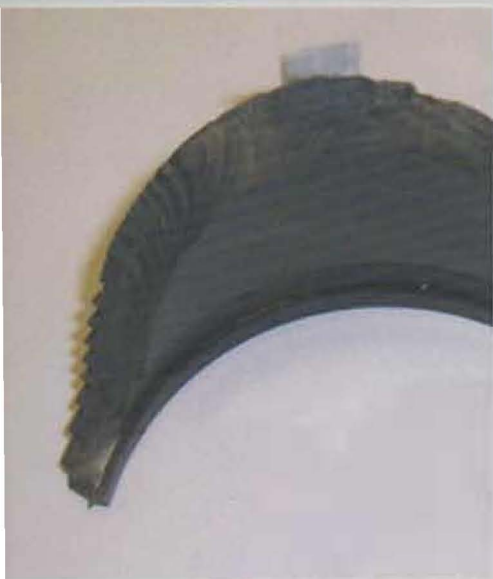
**(Top)** The straight, Y-shaped fracture lines on this fitting probably resulted from water freezing inside the PVC piping. The pieces typically remain close to the source of the failure.

When water freezes inside PVC piping, the material may fail because of the natural phenomenon of cold “embrittlement.” Breaks caused by frozen water have sharp edges, similar to those previously described.

a V- or Y-shaped form. Pieces are not scattered but rest close to the source.

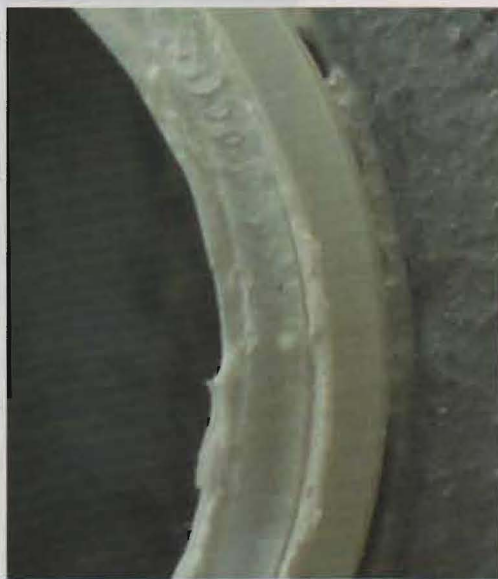
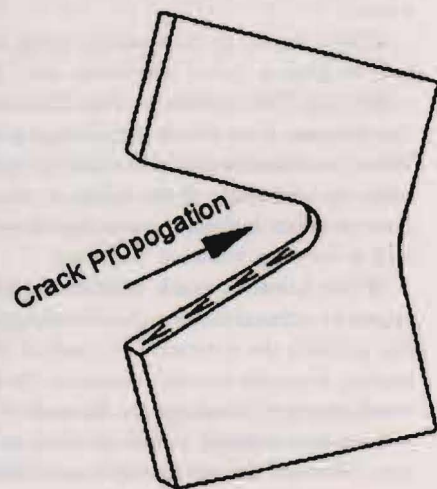
**(Bottom)** Tell-tale signs of failures that result from a slow progression include "beach marks" (left) and a deformity known as "creep" (center). Creep failure most commonly occurs near the interior of a direction change often called the crotch (right).

The fracture surface that results from a slow progression has a defined pattern often labeled as "beach marks." The ridges and valleys of the fracture surface also point toward the failure's origin. This mode is generally the consequence of a failure that progresses over a "long term" and multiple incidents of the cause. Still, in the vernacular of failure analysis, "long term" can be short in the span of time — maybe even a fraction of a second. Besides, many times the failure timeline will consist of beach marks at the beginning, and end with a catastrophic result.

Because plastics — and specifically PVC — are pliable, a failure that is a result of long-term stress shows various amounts of creep. Creep is the tendency of a solid material to deform permanently under the persuasion of loads. It occurs because of continuing exposure to levels of stress that are below the failure strength of the material. The appearance of a failure that is the result of many pressure cycles over a long time will have beach marks on the fracture surface.

Creep failure most commonly occurs at directional fittings, near the interior of a "direction change" often called the crotch. PVC is a visco-elastic material and reacts more like taffy than glass to tensile loads. Slow, medium loads will cause the material to stretch. But a sharply applied load will cause the material to snap. A failure from multiple surge cycles will have "stretch marks" at the end of any surface crack. Many times these indicators can foretell system leaks.

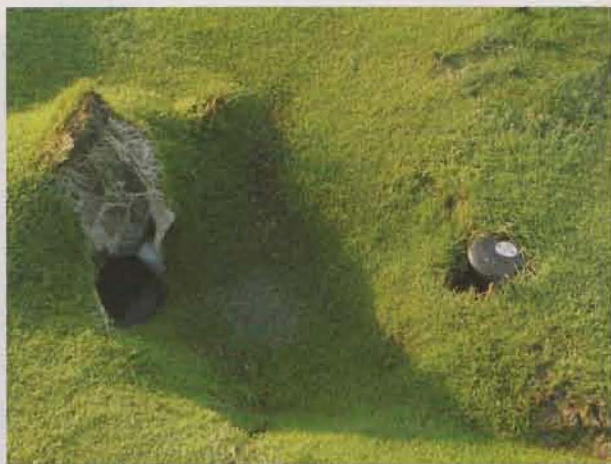
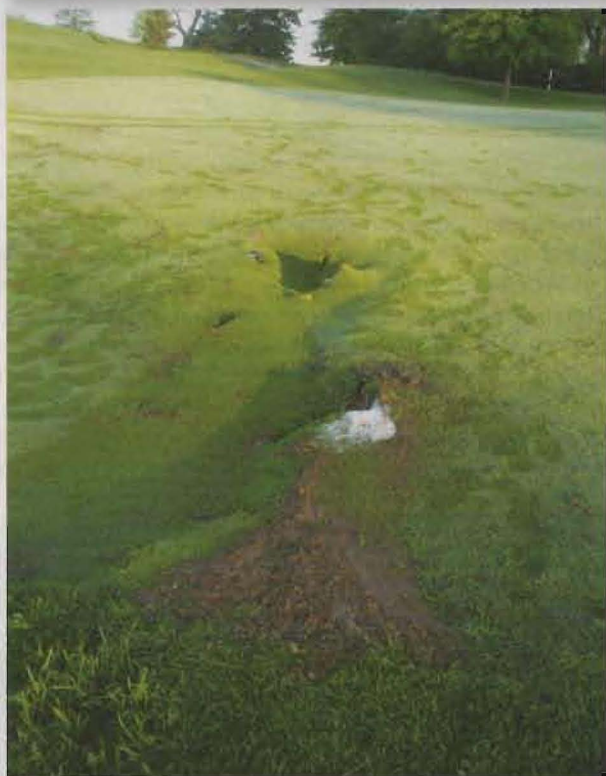
No one needs to tell superintendents about the damage that can come from an irrigation system blowout, like the one shown in these photos from Lawrence CC. However, a little forensic analysis on a leak can keep you from suffering through potentially bigger leaks in the future. **Photos courtesy of Lawrence CC**

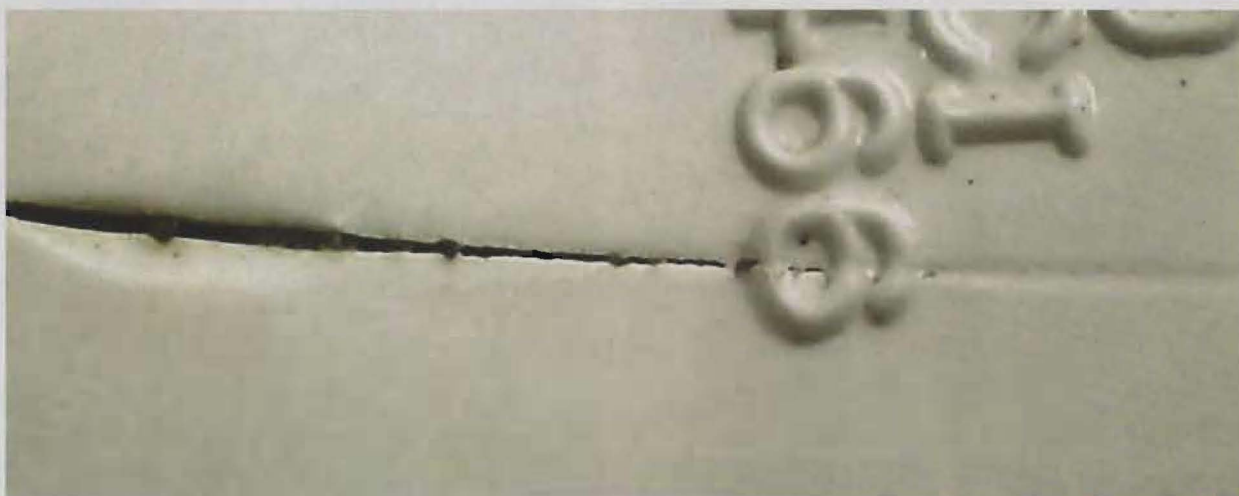
Failure from multiple surge cycles will have "stretch marks" at the end of any surface crack.

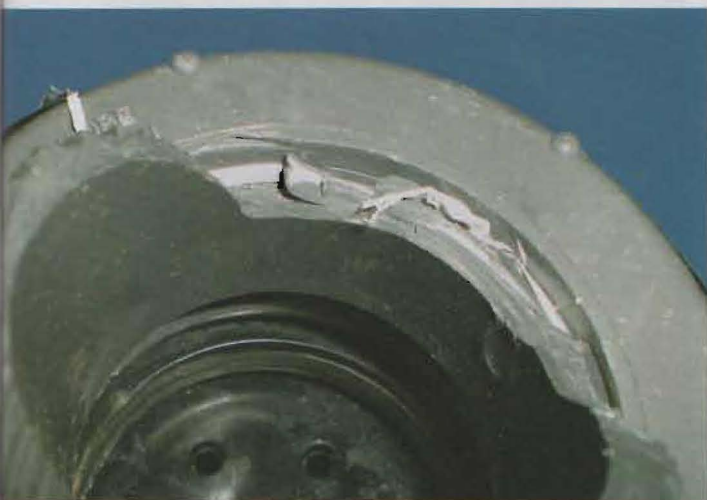
The failure pictured here is at the structurally weakest link of a joint: the first exposed thread of the male part.

The taper of a male thread removes some pipe wall in the threaded segment. This and the inherent stress riser at the root, or bottom, of the thread create a weakness in the joint. This drop in structural strength becomes the potential for failure at the point of the first exposed male thread, outside of the female.

Any external bending or vibration on this connection will soon end with the male threaded part failing at the root of its first exposed thread. Structurally, this is the weakest link of the joint.

common misconception is that using Schedule 80 threaded fittings will prevent this failure. The only solution is to use proper installation procedures and not to over-tighten the joint.
