# Failure analysis 101

**When the irrigation system blows, a little detective work helps determine the cause.**

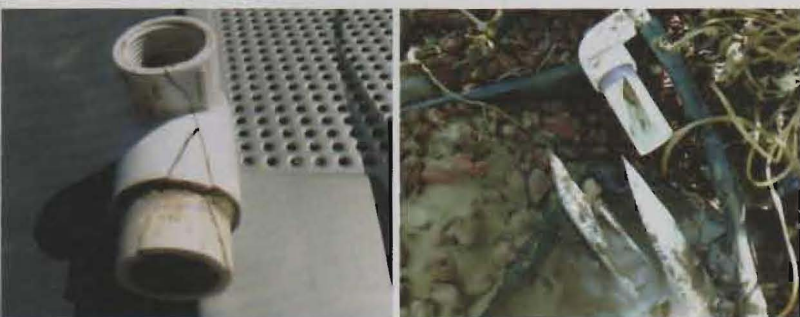
The sharp, jagged edges of this PVC piping indicate a failure from extreme pressure and probably were found after a burst-pressure test. Photos courtesy of Larry Workman

The texture of the failure surface shows a lot about its progression. Sharp, jagged edges are a strong sign of rapid failure. Brittle material or failures from extreme pressure result in almost razor-sharp fragments.

You'll usually find damage of this type after a burst-pressure test. When a water-filled system is pressure-tested, the sharp and dangerous fragments will be contained within a few yards. But when the system has been leak-tested with air or has an air pocket, a failure can propel these shrapnel-like pieces hundreds of feet, creating the potential for serious injury.
