Knitlines, Bondlines & Weldlines

... what are they?

By Larry Workman

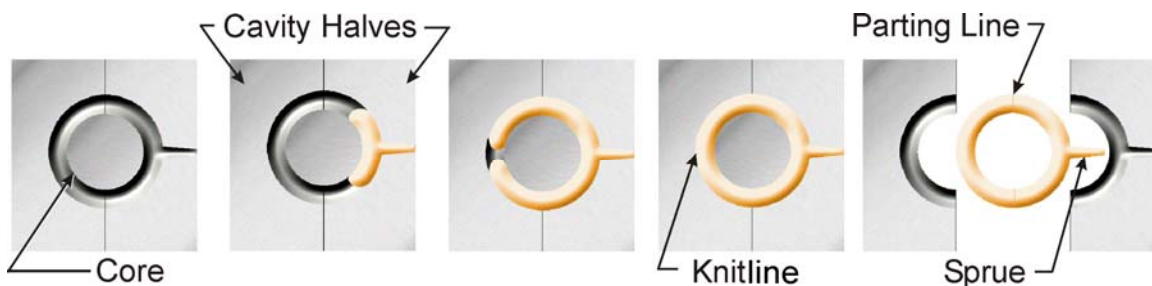
The hot melted plastic flows into the mold cavity, and is diverted around a core, or piece of metal that forms the internal passage of the fitting. A line is created as the separated molten plastic flows around the core and “bonds” or “knits” together. The line is the result of the “cooled skin effect” on the leading edge of the flow. This is similar to what would happen with molten lava as the exterior is dark and semi solid while the interior is still hot and molten.

Injection molded fittings are produced by large machines that feed raw plastic stock, in powder or pellet form, into a giant feed screw. This large feed screw, which resembles an old fashion meat grinder, rotates within a barrel and compresses the plastic by heat generated mainly by friction. At the outlet of the barrel, the molten plastic is pushed or injected into a metal mold. Since all fittings are cylindrical in shape, the filling of the mold with molten plastic is what causes the Knitline.

The Knitline is formed by the encounter of the leading edges of molten plastic flowing around a core, and is located on the opposite side of the fitting from the gate or sprue. The gate is where the plastic is introduced into a mold and can usually be identified by a bump or dimple on the surface of the fitting. The Knitline tends to be more obvious on the darker fittings, like the gray Schedule 80, than on fittings made of white material.

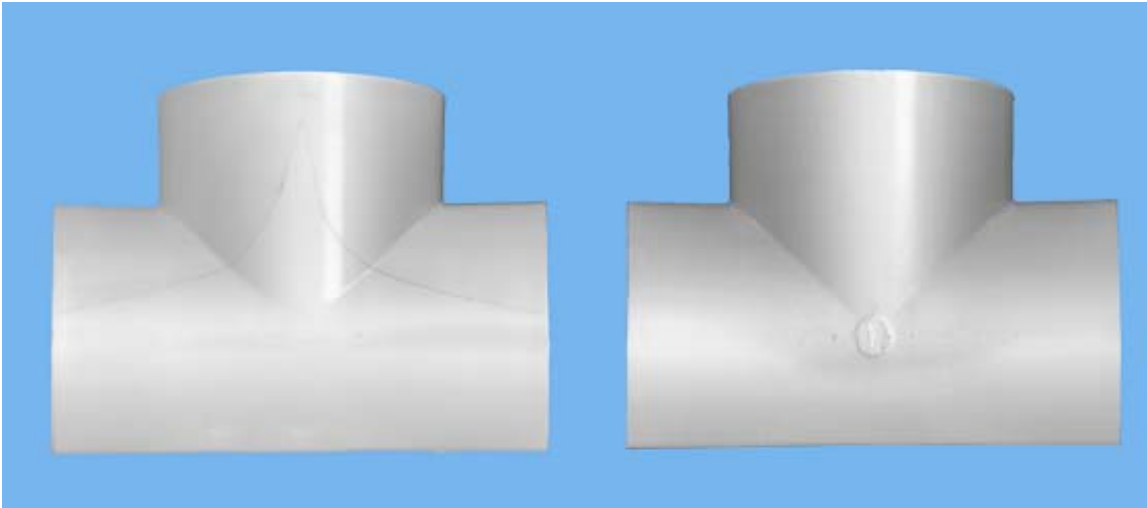
Knitline & Gate mark

The next time you are suspicious of having cracked PVC fitting first, look for the sprue. If you see a crack in the side of the fitting opposite the sprue and it's not in the crotch area, it is more than likely a Knitline! Remember the Knitline, Bondline, or Weldline is on the opposite side of the fitting from the sprue or gate mark.
